Application note

Bond seam inspection

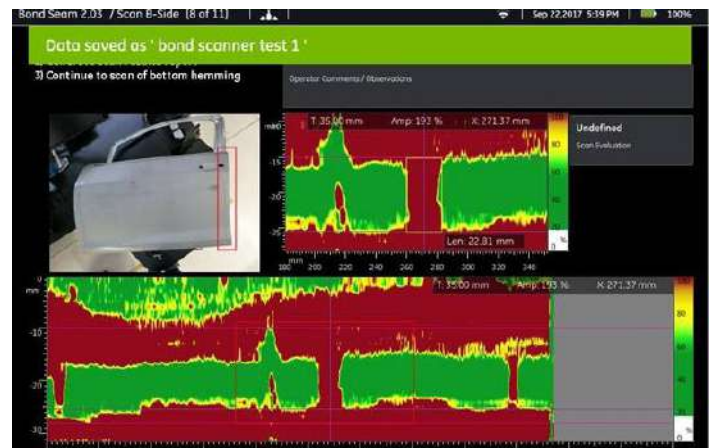
Green indicates strong adhesive bonding; Red indicates missing adhesive
Note areas of slight adhesive leakage

The innovative Bond Seam Scanner linear array design ensures inspection spatial resolution and detection resulting in an easily interpreted visual image of the presence of adhesive allowing the operator to evaluate the overall width of his bond seam and identify where adhesive requirements are not met.
